SCHOOL BUILDING RESTORED WITH BELZONA

Application: WPA-Wall Problem Areas

Substrate: Bath Stone & Brick Fascia

Customer Location: Comprehensive School, South Wales

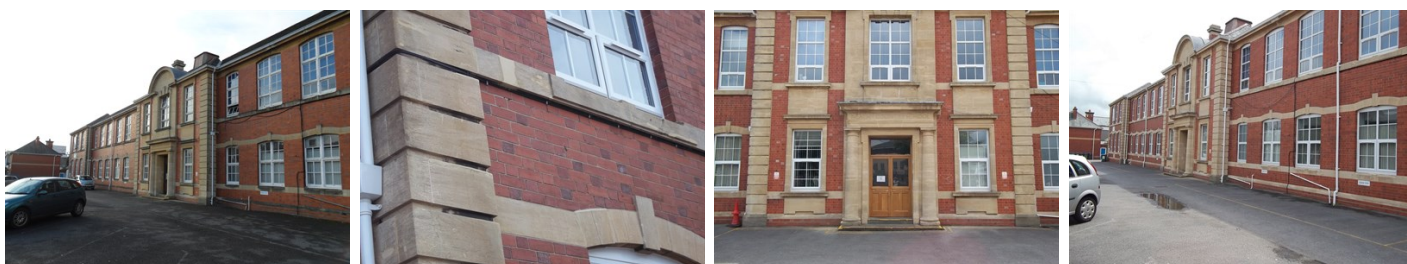
Photograph Descriptions

The stone work was weathering and the brick work was dirty. In addition there were areas suffering from rainwater ingress.

- * Front of the school with damaged areas of concrete ,
- * Damaged areas repaired with Belzona 4141 ,
- * Application of Belzona 5122 ,
- * Completed application ,

Application was carried out in accordance with Belzona System Leaflets WPA-4 & 8. The Belzona 4141 was tinted with a cement tone additive to colour match the repair with the Bath Stone and to ensure a visually pleasing repair. The final stage of the application was to overcoat the surface with Belzona 5122.
