# Belzona Seals A Transformer Lid Flange

ID: 3975

**Customer Location:** Gas Distributor, UK  
**Application Date:** 2011

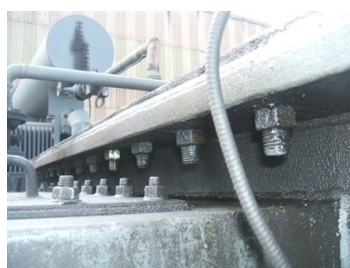
Most of the gasket had failed around the 10m perimeter of the lid, with oil seeping down the sides and going to ground. Unfortunately it was not possible to drain the oil below the gasket level and so the application had to be pursued as a live leak with a 1m head pressure.

- \* 1. Original condition of flange, with header tank at rear. ,
- \* 2. Encapsulation of bolts with Belzona 1161. ,
- \* 3. Completed repair close up. ,
- \* 4. Finished work after 3 days. ,

Lid gasket failure resulted in extensive oil leaks around flange on this 66-11Kv transformer.

Application was carried using Belzona Know-How System Leaflet VPF-11a as a guide. Area of flange and bolts were pressure cleaned and grit blasted. Live leaks stemmed with Belzona 1291 (ES Metal) and Belzona 1221 (Super E Metal). Bolt heads top and bottom were encapsulated with Belzona 1161 (Super UW Metal). Belzona 1161 (UW Metal) and Belzona 9341 (Reinforcement Sheet) were used to create a reinforced band around the flange. Finally over coated with Belzona 5831 (ST Barrier).
