BELZONA ELASTOMER REPAIR TO SEVERELY DAMAGED HOSE

ID: 398

Customer Location: *Dredging Company in Holland*
Application Date: *October 1987*

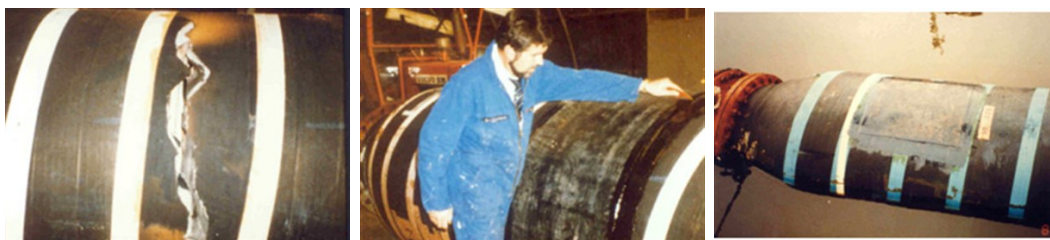
Photograph Descriptions

Holes, cuts and tears in the rubber covers of five floating pipes.

- * Typical tear in rubber pipe. ,
- * Application of Belzona® 2111. ,
- * Floating pipe in service with neoprene patch bonded with Belzona® 2111. ,

Application carried out in accordance with Belzona Know-How System Leaflet SOS-12.

Belzona Elastomer repairs offer a rapid solution to torn and damaged floating hoses, at a fraction of the replacement cost. Additional strength was provided in some areas by bonding Neoprene rubber sheets over damaged areas.
