BELZONA INSIDE A GEAR BOX

Industry: Pulp & Paper
Application: CEP-Centrifugal Pumps
Substrate: Cast Iron
Products: * Belzona® 1341 (Supermetalglide) ,

Customer Location: Paper Mill near the Florida panhandle
Application Date: July 1995

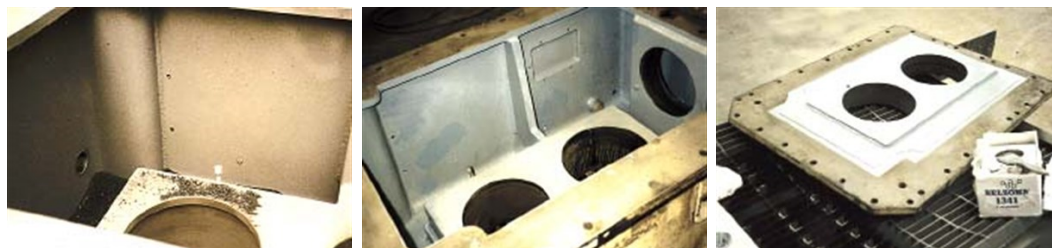
Photograph Descriptions

Corrosion of gear box due to moisture and condensation. Previous internal coatings have failed.

- * Internal surface of gear box grit blasted for surface preparation. ,
- * Inside coated with Belzona® 1341 (Supermetalglide). ,
- * The lid of the gear box was also coated. ,

The application was carried out in accordance with a modified version of Belzona Know-How Leaflet CEP-3.

After 2-1/2 years in service, the Belzona coating is in excellent condition. Saving the gear box housing helps protect its expensive gearing and prevents costly downtime. Two gear boxes were coated.
