BELZONA SOLVES DREDGE PUMP WOES

Application: CEP-Centrifugal Pumps

Dredge pump repair.

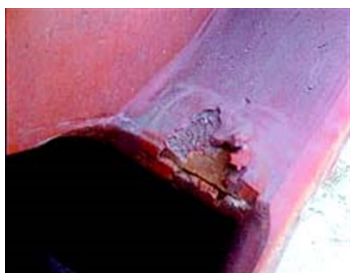
Large roots and stones damaged cutwater and stripped rubber coating from pump.

- * The damage ,
- * Completed repair ,
- * Dredge pump ready for service ,
