# BELZONA RAPID ELASTOMER REPAIR TO CHOKE AND KILL HOSE

ID: 400

Customer Location: Offshore Oil Company  
Application Date: February 2001

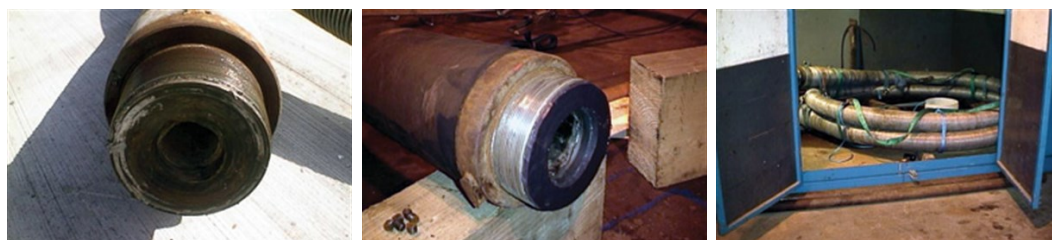
Damage had been caused to the rubber on the sealing face of the male hose connector, due to contact with sharp metal edges on the female connector. As a result of this a satisfactory seal was not being obtained and the customer was faced with returning them to the manufacturer for refurbishment.

- \* Damage to the rubber lining on the male connector. ,
- \* A new sealing face is produced using Belzona® 2311. ,
- \* The hose during pressure testing to 1300 bar. ,

The sealing face was manually prepared and the sealing face formed using an adaptation of Belzona Know-How System Leaflet GSS-1.

As the customer was faced with returning the hoses to the manufacturer, the use of Belzona® 2311 resulted in a significant cost saving, as well as ensuring that the units were returned to service as quickly as possible. The Belzona® 2311 repair was subjected to pressure testing prior to the hoses being returned to service and was successfully completed at 1300 bar.
