# Roof penetration problem solved with Belzona

Application: RPA-Roof Problem Areas

Substrate: Metal Roof

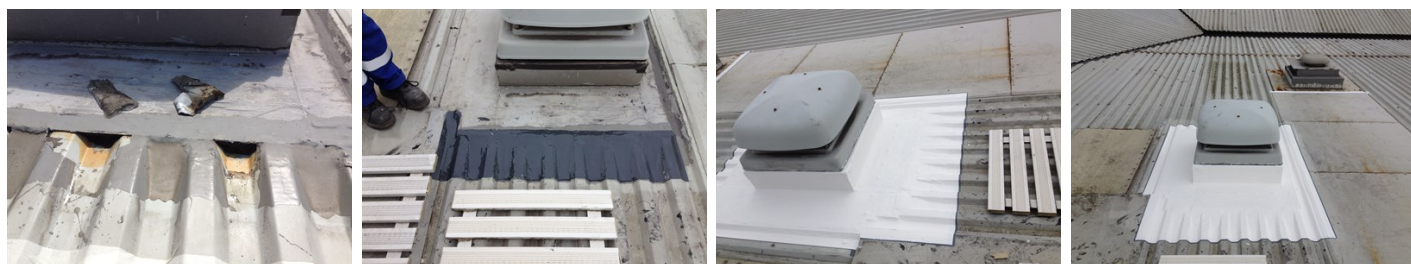
## Photograph Descriptions

An extraction vent had created a leak at its penetration which could create a slip problem in the factory below

- \* 1. Problem area ,
- \* 2. Belzona elastomer used to prevent standing water ,
- \* 3. Completed repair ,
- \* 4. Completed repair ,

The application was carried out in accordance with RPA-1. The problem had been made worse by standing water in the troughs, which had caused the existing seal to have to work harder. The Belzona Consultant included as part of the repair, the use of Belzona elastomers (due to the flexing of the roof) to allow the water to shed effectively.
