Belzona repairs damaged pre-heater fan shaft

ID: 4024

Industry: General Industry
Application: MPT-Mechanical Power Transmission

Substrate: Steel
Products: * Belzona 1111 (Super metal) ,

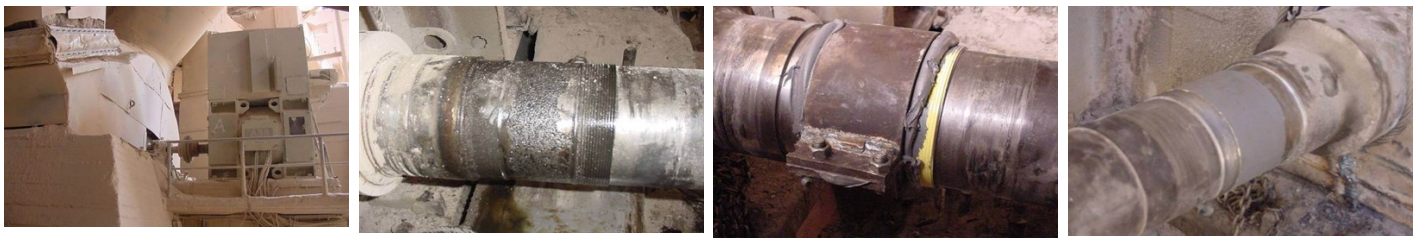
Photograph Descriptions

The shaft was worn out under the bearing.

- * 1. The damaged equipment ,
- * 2. The damaged area ,
- * 3. The application before removal of formers ,
- * 4. The completed application ,

Worn shaft

This application was carried out in accordance with MPT-2. The shaft can be returned to its original dimensions by using released split formers. These can easily be removed once the product has cured to reveal a perfect finish.
