# Belzona repairs damaged pre-heater fan shaft

Industry: *General Industry*  
Application: *MPT-Mechanical Power Transmission*

Substrate: *Steel*  
Products: *\* Belzona 1111 (Super metal) ,*

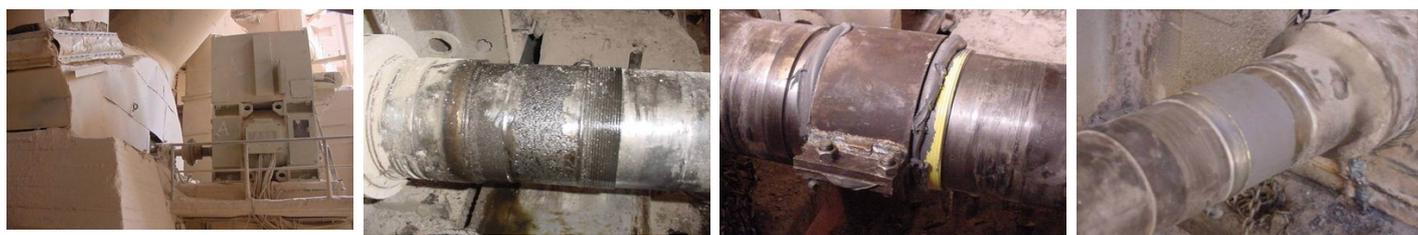
*The shaft was worn out under the bearing.*

- \* 1. The damaged equipment ,
- \* 2. The damaged area ,
- \* 3. The application before removal of formers ,
- \* 4. The completed application ,

Worn shaft

This application was carried out in accordance with MPT-2. The shaft can be returned to its original dimensions by using released split formers. These can easily be removed once the product has cured to reveal a perfect finish.
