BELZONA REPAIRS BALL MILL SHELL

ID: 4025

Customer Location: Cement plant, Al Kawmeya, Egypt
Application Date: October 2008

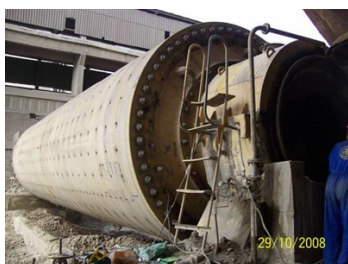
Due to the nature of the operation, the internal surfaces of the ball mill are subject to constant impact from the falling balls and other media present inside. Shell wall became damaged beneath the wear plates.

- * Damaged ball mill ,
- * Impact damage ,
- * Surface after preparation ,
- * Completed application ,

Ball mill shell damaged beneath wear plates.

Application was carried out in accordance with Belzona Know-How System Leaflet SHM-7. After surface preparation, Belzona 1311 was used to rebuild the damaged areas to restore the original dimensions.
