BELZONA PROTECTS CRUDE OIL STORAGE TANK

ID: 403

Customer Location: Tank Farm - Mexico
Application Date: August 2001

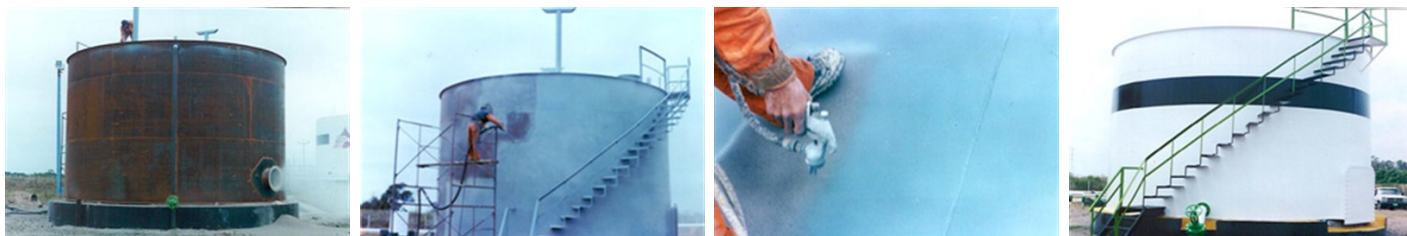
Photograph Descriptions

Due to the tank farm's proximity to the coast, a host of components, including abrasion from the sand, salt air, contamination from residual sour gas and other chemical components, contributed to the accelerated erosion/corrosion of the exterior of the storage tank.

- * Overall condition of the tank before the application of the Belzona coating system. ,
- * Grit blasting taking place. ,
- * Application of Belzona® 6111 using spray equipment. ,
- * View of the tank once the Belzona coating system had been applied. ,

Exterior coating of 1000-barrel crude oil storage tank.

Modified version of Belzona Know-How System Leaflet TCC-5.

The Belzona coating system allowed for the protection of the tank, thereby providing the needed abrasion and chemical resistance.
