# Belzona repairs and protects rudder stock

ID: 4038

Industry: *Marine*  
Application: *MPT-Mechanical Power Transmission*

Customer Location: *Egypt*  
Application Date: *August 2007*

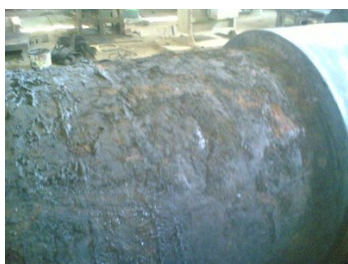
*Ships rudder stock was suffering from the effects of erosion-corrosion*

- \* 1. Corrosion-erosion damage. ,
- \* 2. Belzona 1111 successfully applied ,
- \* 3. Belzona 1321 successfully applied ,
- \* 4. Back in service after repair completion ,
