Belzona repairs and protects rudder stock

ID: 4038

Industry: *Marine*
Application: *MPT-Mechanical Power Transmission*

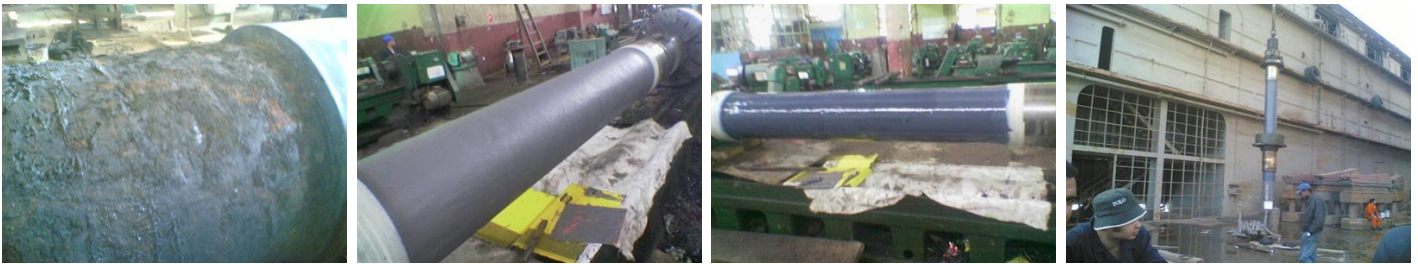
Photograph Descriptions

Ships rudder stock was suffering from the effects of erosion-corrosion

- * 1. Corrosion-erosion damage. ,
- * 2. Belzona 1111 successfully applied ,
- * 3. Belzona 1321 successfully applied ,
- * 4. Back in service after repair completion ,

This repair was carried out in accordance with MPT-1. The damaged area was rebuilt using Belzona 1111 (Supermetal) before the area was protected from further damage with Belzona 1321 (Ceramic S-Metal).
