Belzona provides internal corrosive resistant lining

ID: 4041

Industry: Oil & Gas
Application: TCC-Tanks and Chemical Containment Areas
Substrate: Carbon Steel
Products: * Belzona 5811 (Immersion Grade),

Customer Location: Egypt
Application Date: March 2006

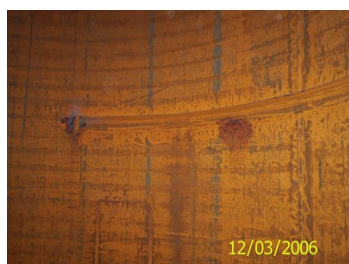
Corrosion occurring on the internal surfaces which needed to be protected.

- * 1. Corrosion Damage ,
- * 2. 1st coat successfully applied ,
- * 3. 2nd coat application ,
- * 4. Completed application ,

The repair was carried out in accordance with TCC-3. The two different coloured coats of Belzona 5811 were applied to avoid any pinholes or misses.
