# AN UPLIFTING BELZONA SOLUTION

ID: 407

**Customer Location:** Refinery - Brazil  
**Application Date:** August 2003

Relocation of two 22-ton riveted storage tanks.

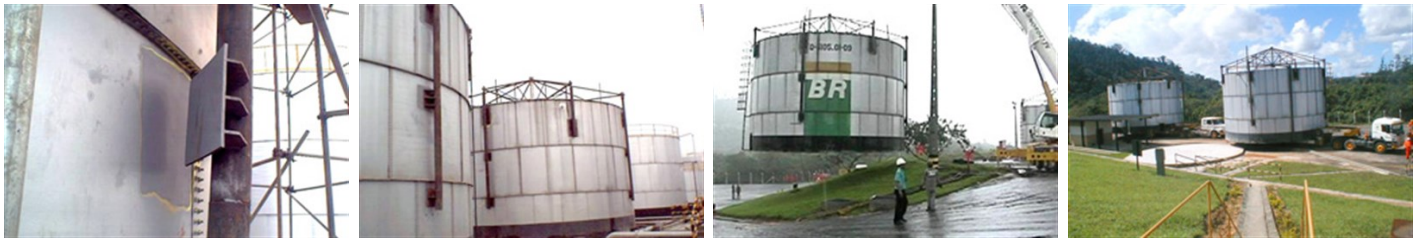
- \* View of the metal pad to be bonded against the exterior wall of the tank. ,
- \* View of the tanks, each with pads bonded in place, along with the upper support structure installed ,
- \* One of the tanks being lifted with a crane ,
- \* The tanks were moved 200 meters and 15Km respectively ,

The Belzona Technical Consultant, the end-user and an engineering company all became involved in devising the correct procedure with which to move the two tanks. Sixteen metal pads were bonded to each tank. A metal support structure was erected so as to prevent the walls from collapsing. Calculations of the mechanical properties of Belzona® 1111 revealed that by carrying out the application as planned that 420 tons could be supported. This presented a safety margin of approximately 1,170%.
