# BELZONA PROTECTS LARGE BUTTERFLY VALVE

**Industry:** Power  
**Application:** VPF-Valves, Pipes and Fittings  
**Substrate:** Cast Iron  
**Products:** \* Belzona® 1311 (Ceramic R-Metal) ,  
\* Belzona® 1321 (Ceramic S-Metal) ,

**Customer Location:** Power station - Ireland  
**Application Date:** 2003

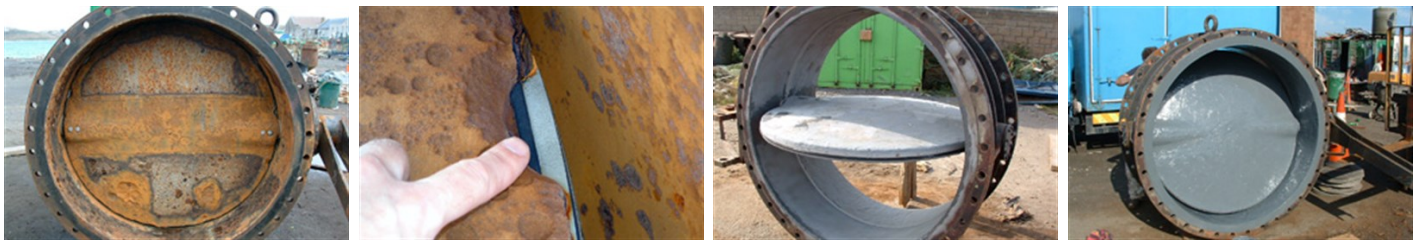
Severe erosion-corrosion on the body and particularly the valve disc.

- \* Valve removed ,
- \* Degree of erosion on the disc clearly evident ,
- \* Application underway ,
- \* Completed application ,

Application was carried out in accordance with Belzona Know-How System Leaflets VPF-1 and VPF-2.

Weld repairs were not considered viable on the cast iron valve body. Belzona was the only cost effective alternative to replacing the valves at a cost of approximately €20,000 (\$24,000).
