BELZONA PROTECTS LARGE BUTTERFLY VALVE

ID: 408

Customer Location: Power station - Ireland
Application Date: 2003

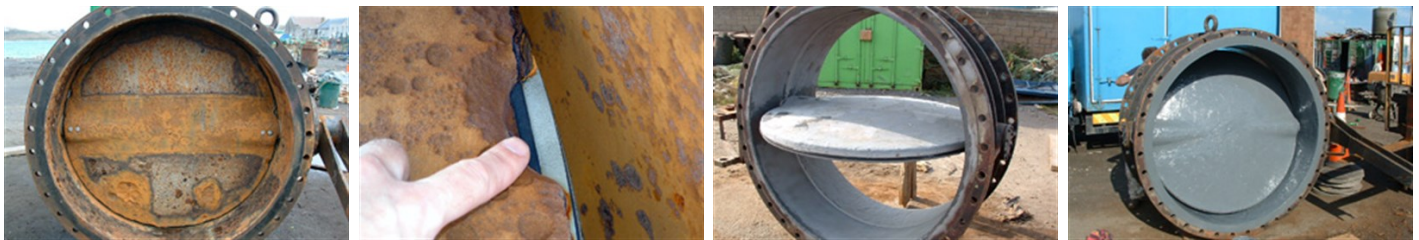
Photograph Descriptions

Severe erosion-corrosion on the body and particularly the valve disc.

- * Valve removed ,
- * Degree of erosion on the disc clearly evident ,
- * Application underway ,
- * Completed application ,

Application was carried out in accordance with Belzona Know-How System Leaflets VPF-1 and VPF-2.

Weld repairs were not considered viable on the cast iron valve body. Belzona was the only cost effective alternative to replacing the valves at a cost of approximately €20,000 (\$24,000).
