BELZONA REPAIR TO STONE CRUSHER SHAFT

ID: 409

Industry: *Cement*
Application: *MPT-Mechanical Power Transmission*

Customer Location: *Cement plant in Bulgaria*
Application Date: *May & June 2003*

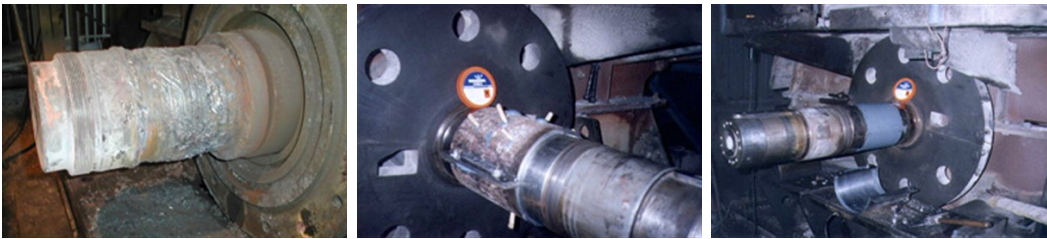
Photograph Descriptions

Severe wear on these 230mm diameter shafts caused by extreme loads, vibration and abrasion from dust leads to bearing failure.

- * Severely damaged shaft ,
- * Former in place and Belzona® 1321 injected ,
- * Former removed and ready for re-assembly of bearing ,

Application was carried out in accordance with Belzona Know-How System Leaflet MPT-2. Belzona® 1321 was injected after positioning the former over the damaged area of the shaft.

The Belzona application is carried out quickly in situ leading to minimum plant downtime. Shafts are still performing satisfactory after 6 months service.
