Belzona SuperWrap en refinería

ID: 4094

Línea de alimentación de crudo en refinería

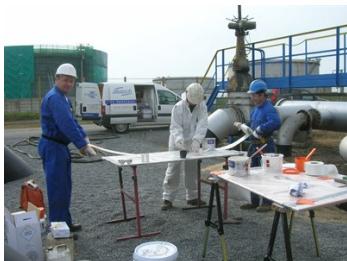
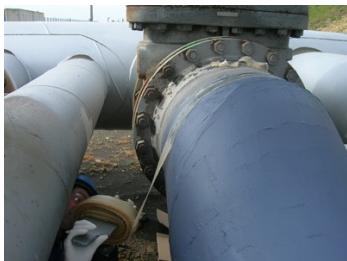
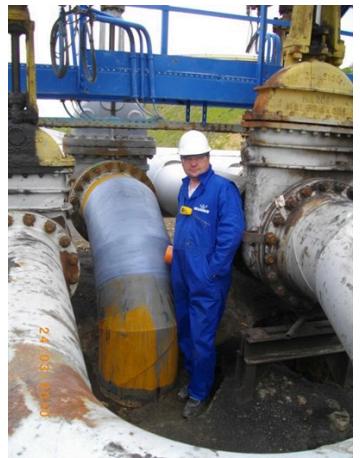
Descripciones de fotografías

Se produjo corrosión en la sección de la tubería soterrada en la parte donde ésta emerge. La alta humedad a este nivel del suelo causó una severa corrosión en estas secciones expuestas de la tubería.

- * Vista general de la refinería ,
- * Preparación ,
- * Aplicación en progreso ,
- * Reparación completada ,

El Sistema Belzona SuperWrap fue instalado de acuerdo con los requerimientos ISO/TS 24817 y ASME PCC-2.

Belzona SuperWrap se aplica con rapidez in situ y es una alternativa de fraguado en frío a la soldadura tradicional. Este sistema ha
