BELZONA PROTECTS COOLING WATER SPOOLS

ID: 410

Customer Location: Power station - Ireland
Application Date: 2003

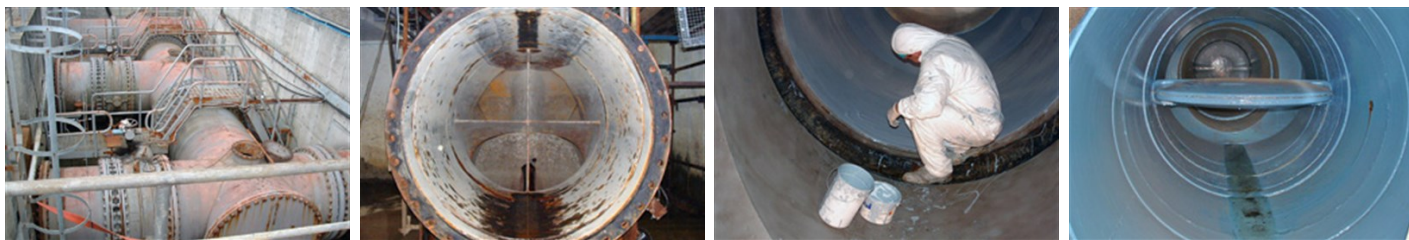
Photograph Descriptions

Previous coating was badly damaged allowing severe erosion-corrosion on pipework internals.

- * General view of the spools ,
- * Degree of original erosion clearly evident ,
- * Application underway ,
- * Completed application ,

Main cooling water intake pipework.

Application was carried out in accordance with Belzona Know-How System Leaflet VPF-2.

Some spools were so badly corroded that they had to be replaced or sleeved. The Belzona® 1341 coating will prevent future costly replacement becoming necessary.
