# BELZONA REPAIRS TO RUBBER LINED CONDENSER

ID: 411

Industry: Power

Application: HEX-Heat Exchangers

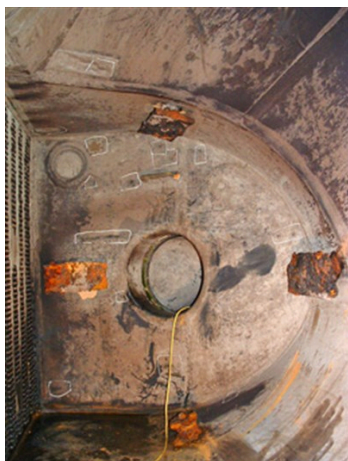
Spark testing of rubber lining highlighted several defects requiring repair.

- \* Damaged areas of lining identified and marked ready for repair. ,
- \* The repair area masked off to ensure application is kept within prepared area. Conditioner being applied. ,
- \* One of the many local repairs completed. ,

Application was carried out in accordance with Belzona Know-How System Leaflet HEX-4. Spark testing identified defects which were then locally repaired.

Excellent adhesion and ambient curing properties of Belzona Elastomer allow effective long term repairs to be carried out within the confines of the water box.
