BELZONA® 5851 ON OFFSHORE PIPEWORK

ID: 412

Corrosion Under Insulation (CUI) on heating medium pipework.

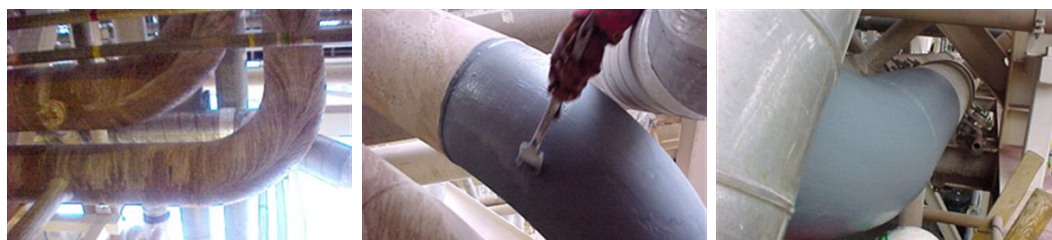
The presence of insulation around the heating medium pipework had led to some corrosion of the pipework over a period of time. During a routine inspection it was decided that applying Belzona® 5851 whilst the pipework remained in service represented the best option to prevent future corrosion.

- * Corrosion to heating medium pipework ,
- * Application of first coat of Belzona® 5851 ,
- * Completed application ,

The pipework was wet-blasted, allowed to dry and any residual aggregate brushed off. Some flash rusting was evident, and considered acceptable prior to application of two 250 micron coats of Belzona® 5851.
