Abrasion protection for coal classifiers with Belzona® 1813

ID: 4121

Application: SHM-Solids Handling Machinery

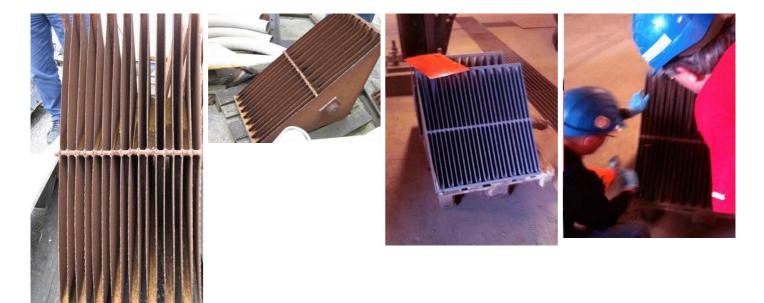
Photograph Descriptions

Extensive abrasion and wear

- * View of one of the coal dust classifiers ,
- * Close-up of a coal classifier showing the wear (top right) ,
- * Completed surface preparation ,
- * Application in progress,

Coal-fired power station. The coal classifier is installed behind the coal pulverising mills. The pulverised coal is subsequently injected into the boiler furnace via the coal classifier.

Initially, an ASR form was completed and reviewed by the technical team. Belzona® 1813 was applied by hand to the classifier edges and plate sides to a depth of approximately 100 mm.

The life of each classifier had been about six months, with service conditions including temperatures of up to 160°C (dry) and a throughput rate of approximately 5000m3/h per unit. Following the application of Belzona® 1813 on a trial basis, there were few signs of abrasion on the classifier deflector plates upon inspection 10 months later, in 2012. As a result, the customer plans to coat the old classifiers with Belzona® 1813 to prolong service life and other power stations within the group are investigating the use of this technology.
