# INTERIOR COATING OF OIL STORAGE TANK WITH BELZONA

**Industry:** Oil & Gas  
**Application:** TCC-Tanks and Chemical Containment Areas  
**Substrate:** Carbon Steel  
**Products:** \* Belzona® 5811 (Immersion Grade),

**Customer Location:** Oil Company - Mexico  
**Application Date:** December 2003

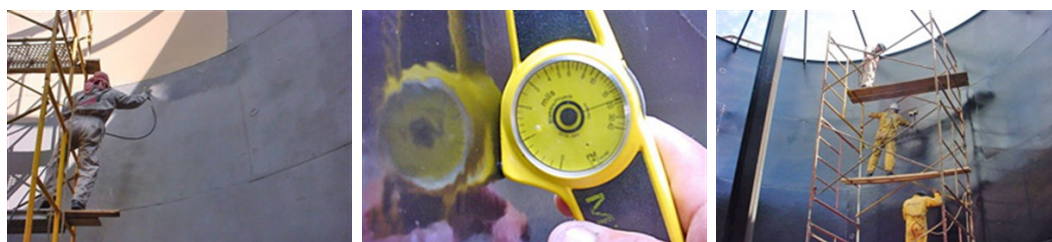
- \* The application of Belzona® 5811 was carried out using a single-pot airless system ,
- \* High quality control was part of this application as is evident by the DFT (dry film thickness) readings that were taken ,
- \* View of the two coat system applied. Low voltage holiday detection was carried out to rule out any pinholes on the coating before putting the tank back into service ,

Interior coating of a 20,000-barrel crude oil storage tank.

Application was carried out in accordance with a modified version of the Belzona Know-How System Leaflet TCC-5.

The application of Belzona® 5811 was carried out using an airless spray system. As such, this large vessel was done at a fraction of the time when compared to conventional application methods. The selected Belzona coating system was chosen for its effectiveness against the anticipated corrosion from the acidic nature of the crude. In addition, it presented a cost-effective and environmentally-friendly product to apply.
