# BELZONA KEEPS DUST SUPPRESSION BOWSER IN SERVICE AT QUARRY

**Industry:** Mining & Quarrying  
**Application:** TCC-Tanks and Chemical Containment Areas  
**Substrate:** Steel  
**Products:** \* Belzona® 1111(Super Metal) ,

**Customer Location:** Limestone quarry, SW, England  
**Application Date:** September 2012

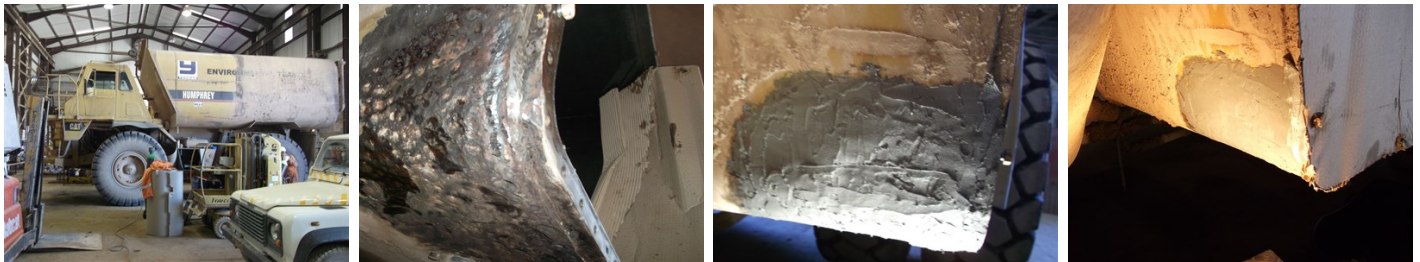
Traditional welding repair had failed to seal the tank. The customer required a fast cold curing solution to bring the bowser back into service.

\* Quarry dust suppression bowser in workshop Damage and Corrosion to be repaired Initial application of Belzona® 1111 Finished application. Cure accelerated by heat ,

Dust suppression bowser had suffered damage and corrosion to its hydraulic tank causing leakage.

Application was carried out in accordance with Belzona Know-How System Leaflet TCC-1.

The time required to remove all the ancillaries and replace the tank would have taken several days which was not acceptable as dust levels in the quarry were high increasing the risk of incident due to poor visibility. The Belzona solution had the bowser back in action the next day.
