COATING AND PROTECTION OF STORAGE TANK FOR PROCESSED WATER WITH BELZONA

ID: 414

Customer Location: Refinery - Brazil
Application Date: September 2003

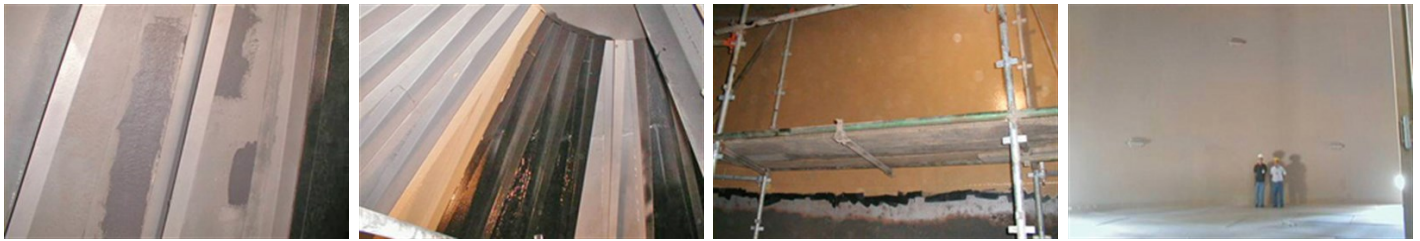
Photograph Descriptions

- * Upper conical portion of the tank being faired out with a Belzona 1000 Series product ,
- * Two-coat system of Belzona® 5811 being applied to the top portion of the tank ,
- * View of the wall being coated with with Belzona® 5811 ,
- * Partial view of the interior of the tank after completion of the application ,

Seven months into the service life of the Belzona coating system, an adjacent fire damaged the top conical sections. Upon closer inspections, it was concluded that the interior walls were intact, and fully operational. The top section was repaired, and ultimately,

coated once again with Belzona® 5811.
