# Belzona seals roof over production area

ID: 4158

Application: RPA-Roof Problem Areas

Customer Location: Manufacturer, UK

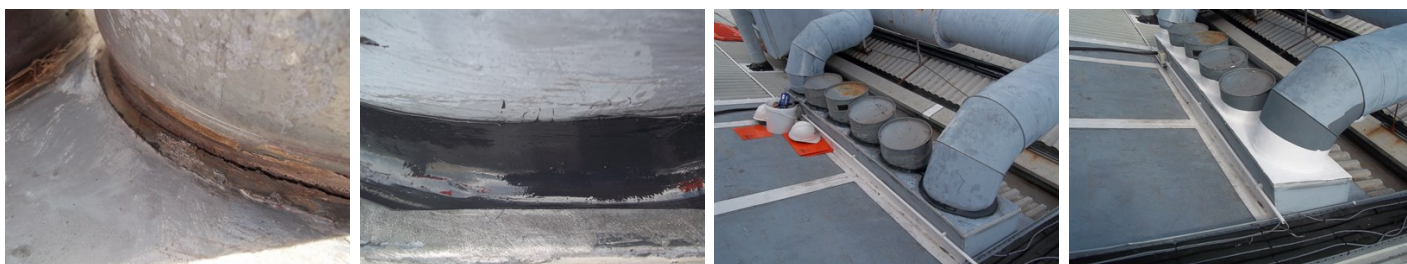
## Photograph Descriptions

*The effect of weather and UV caused rubber seals around ductwork penetrations to degrade allowing rainwater to leak directly into the production area creating disruption in production and safety issues.*

- \* Deteriorated joint ,
- \* Belzona® 2211 applied to seal gap ,
- \* All joints sealed with Belzona Elastomer ,
- \* Fully Reinforced Belzona® 3111 system applied to give additional sealing and protection ,

Application was carried out in accordance with Belzona Know-How System Leaflet RPA-1 and 6. The joints were resealed with Belzona Elastomer, before applying a fully reinforced Belzona® 3111 Flexible Membrane system.

Belzona system was applied in 2 days without disrupting production, giving a long term water and weather resistant solution.
