# BELZONA CREATES SAFE ENTRANCE FOR WORKERS AND VISITORS

ID: 4175

Industry: General Industry  
Application: FPA-Floor Problem Areas  
Substrate: Quarry tile  
Products: \* Belzona® 1321 (Ceramic S-Metal) ,

Customer Location: Building materials manufacturer, Croatia  
Application Date: October, 2012.

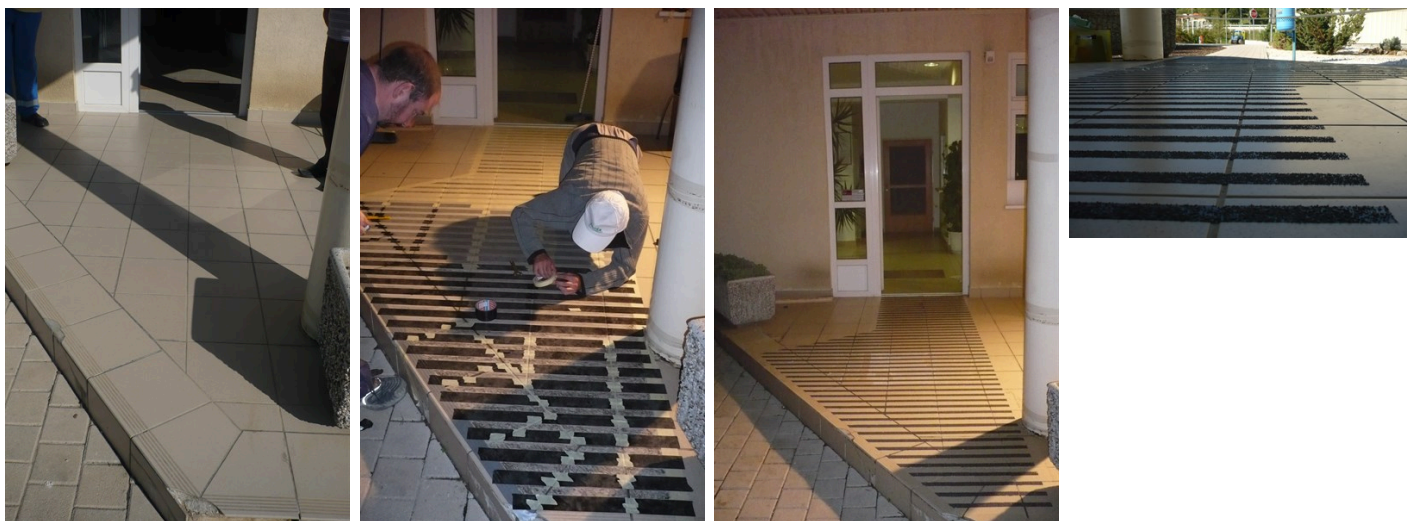
New quarry tiled floor at the entrance to the factory reception was extremely slippery when wet. This identified slip hazard had to be made good by the client.

- \* New quarry tiles that are very slippery when wet ,
- \* Application in progress - creation of pattern ,
- \* Application finished ,
- \* Application finished - close up shot ,

Application was carried out in accordance with Belzona Know-How System Leaflet FPA-8.

Belzona provided an acceptable and cost effective solution. Application was carried out late in the evening, in order not to disturb customers during his operating hours. In the morning the floor was ready. Belzona solution eliminated the trip hazard and provided durable and nice-looking non-slip system. The expensive alternative was to replace the quarry tiles.
