# Corroded Amine Vessel Saved By Belzona

Industry: Oil & Gas  
Application: TCC-Tanks and Chemical Containment Areas  
Substrate: Mild Steel  
Products: \* Belzona 1511 (Super HT Metal) ,  
\* Belzona 1591 (Ceramic XHT Metal) ,

Customer Location: Queensferry  
Application Date: October 11

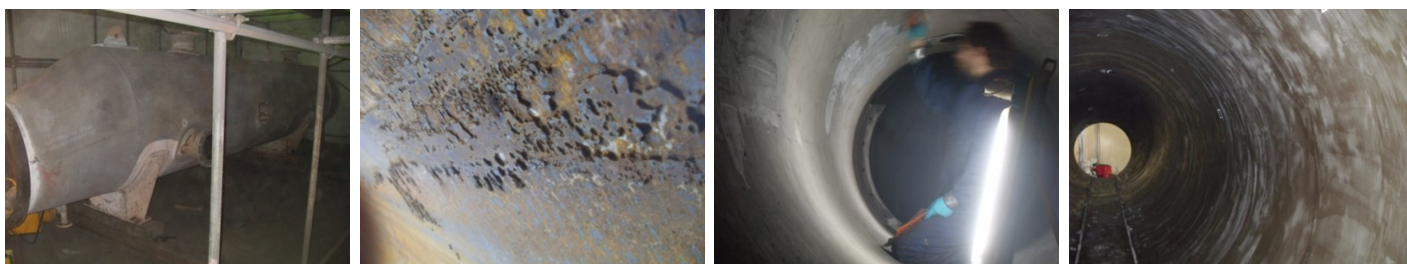
\* Picture 1 - The vessel in a contained environment for blasting. Picture 2 - Pitting and Corrosion Picture 3 - Belzona 1511 applied over pitting Picture 4 - Belzona 1591 Applied ,

An Amine Boiler had suffered from the high temperatures with a high level of pitting and corrosion

The Vessel was grit blasted to SA 2.5 75 microns minimum. All brackets had their edges radius to 3mm. Belzona 1511 Super HT Metal was used to fill in the deep pitting that had occurred. A stripe coat of Belzona 1591 was placed around brackets. Two coats of 1591 was applied with a flash blast between coats. Remedial work was carried out where necessary.
