CLASSIC PIN-HOUSING REPAIR WITH BELZONA

ID: 419

Bush housing on excavator shovel

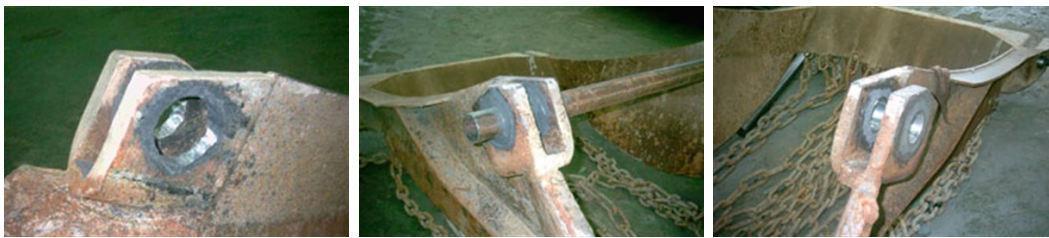
Fretting and wear caused ovality of the bush housing due to the high forces transmitted through the pins.

* The damaged housing Belzona® 1111 applied and the new bushes located in the correct place by a pin between the housings The completed repair ,

Application was carried out in accordance with Belzona Know-How System Leaflet MPT-8. The surface was prepared by grinding and new steel bushes bonded into place. In order to ensure the bushes were in the correct position, a dummy pin was used to locate the bushes.
