# Belzona Rebuilds and Protects Pump Casing and Impeller

ID: 4192

Customer Location: *Port Said, Egypt*  
Application Date: *March 2007*

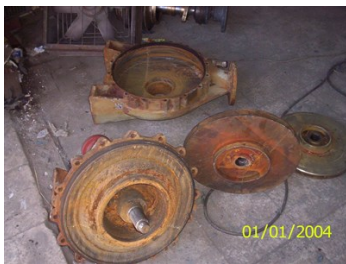
*Pump casing and impeller had become damaged due to erosion-corrosion*

- \* 1. Original Damage ,
- \* 2. Belzona 1311 completed application ,
- \* 3. Belzona 1321 application ,
- \* 4. Completed application ,
