BELZONA PROTECTS PUMP PLINTH

ID: 422

Application: TCC-Tanks and Chemical Containment Areas

Pump Plinth

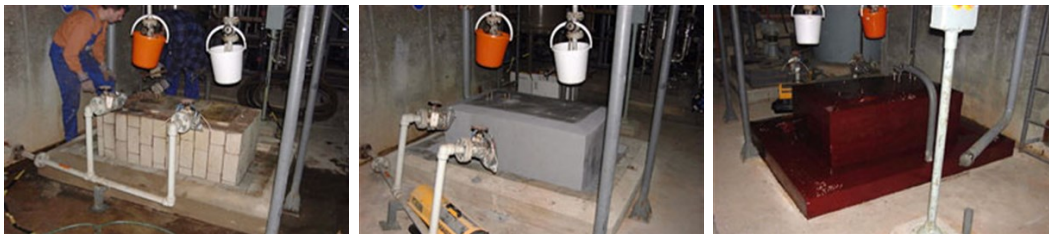
Photograph Descriptions

98% Sulphuric acid leaking from the pump had damaged the grout between the acid resistant tiles and attacked the concrete beneath.

- * The damaged pump plinth ,
- * Rebuilt with Belzona® 4111 ,
- * And coated with Belzona® 4341 ,

After removing the tiles and damaged concrete the plinth was rebuilt to the original size with Belzona® 4111. Two coats of Belzona® 4341 were then applied to offer long term, hot acid protection of the plinth.

The Belzona solution provides a seamless barrier to the acids and has no weak spots. Belzona® 4341 can resist up to 75% H₂SO₄ at 90°C.
