BELZONA® 3211 (LAGSEAL) IN TOUGH ENVIRONMENT - 2ND TIME AROUND

ID: 423

Application: TCC-Tanks and Chemical Containment Areas

Customer Location: Power plant in Texas, USA

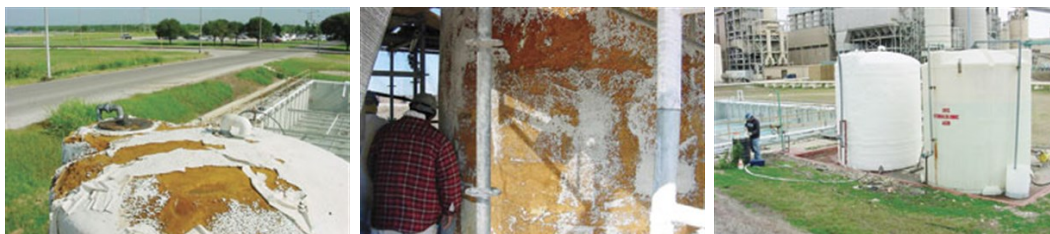
Photograph Descriptions

- * View from acid tank ,
- * Surface preparation ,
- * Belzona® 3211 applied ,

Coating on insulated caustic storage tank

Belzona® 3211 held up well (eight years) in this tough environment. Fumes from neighboring acid tank condensed on a tank, causing rapid deterioration of the previous coatings.

Once the old coating was removed, the application proceeded in accordance with Belzona® Know-How System Leaflet TCC-4.
