BELZONA IN-SITU REPAIRS TO PORCELAIN INSULATORS

ID: 4233

Customer Location: National Grid, UK
Application Date: October 2012

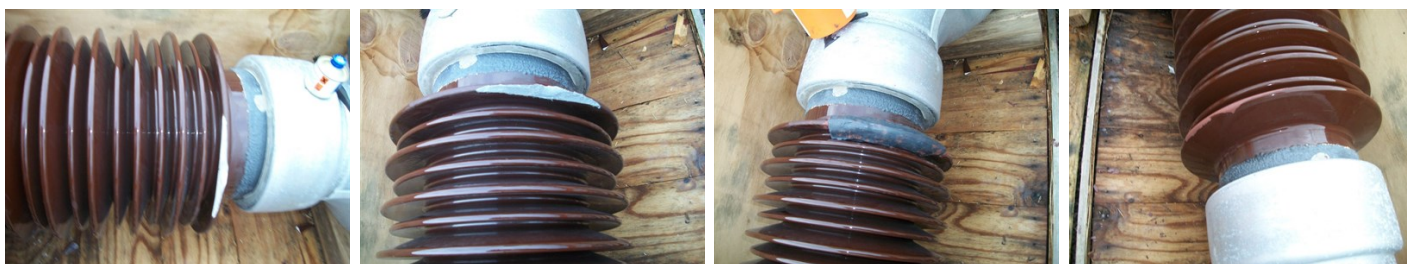
Photograph Descriptions

A brand new porcelain shed had been damaged whilst in transit to the Substation which required an immediate in-situ repair.

- * Damaged porcelain shed in transport crate ,
- * Shed edge wet out with Belzona® 1221 ,
- * Belzona Elastomer former containing Belzona® 8112 ,
- * Completed repair ,

The porcelain insulator rebuild repair was completed in accordance with the Belzona Know-How System Leaflet VPF16.

This in-situ repair was deemed the most cost effective in comparison to the cost of dismantling the insulator stack and replacing the damaged shed.
