# BELZONA IN-SITU REPAIR OF SHAFT FROM PRE-HEATER FAN

ID: 426

Industry: *Cement*  
Application: *MPT-Mechanical Power Transmission*

Customer Location: *Cement works in Egypt*  
Application Date: *March 2002*

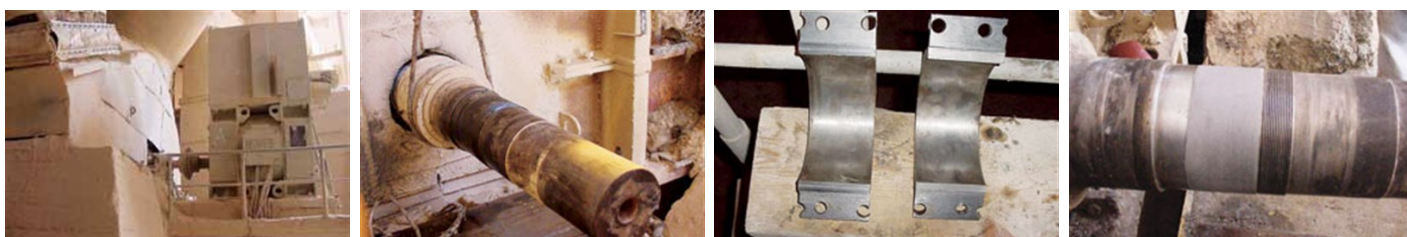
*Worn shaft due to bearing seizure.*

- \* General view of the pre-heater fan housing ,
- \* The damaged shaft ,
- \* The prepared split former ,
- \* Completed application after removing former ,

Application was carried out in accordance with Belzona Know-How System Leaflet MPT-2.

Long term repair effected without having to dismantle and remove rotating element thus realizing savings in both time and costs.
