BELZONA IN-SITU REPAIR OF SHAFT FROM PRE-HEATER FAN

ID: 426

Industry: *Cement*
Application: *MPT-Mechanical Power Transmission*

Customer Location: *Cement works in Egypt*
Application Date: *March 2002*

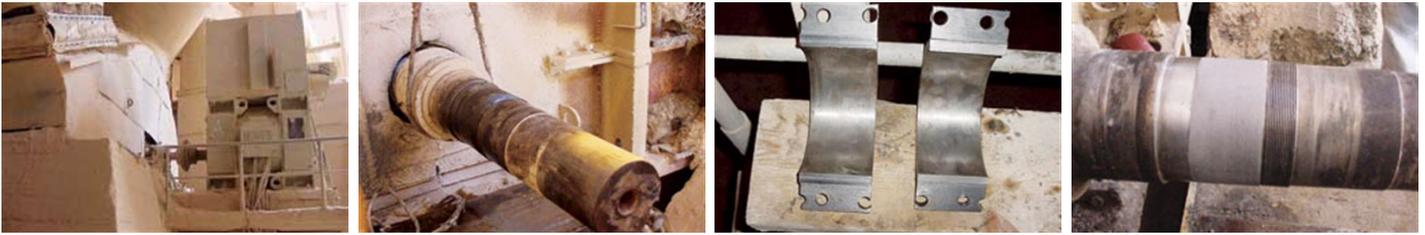
Photograph Descriptions

Worn shaft due to bearing seizure.

- * General view of the pre-heater fan housing ,
- * The damaged shaft ,
- * The prepared split former ,
- * Completed application after removing former ,

Application was carried out in accordance with Belzona Know-How System Leaflet MPT-2.

Long term repair effected without having to dismantle and remove rotating element thus realizing savings in both time and costs.
