# BELZONA REFURBISHMENT OF COOLING WATER PUMP DIFFUSER

ID: 427

**Customer Location:** Power station in Egypt  
**Application Date:** April 2002

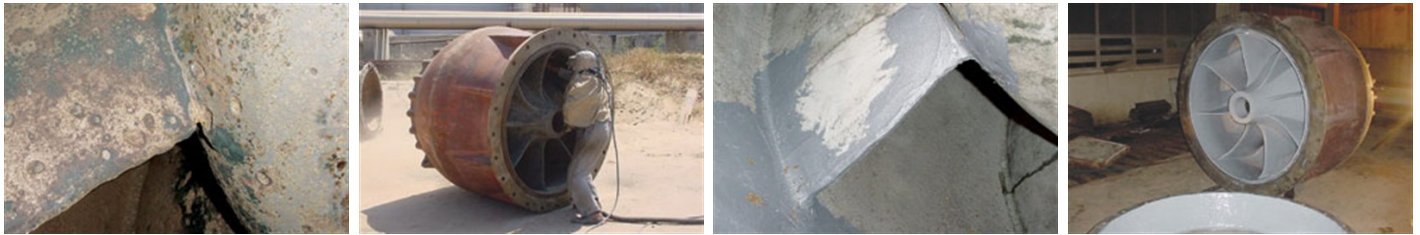
Severe erosion-corrosion.

- \* Severity of erosion clearly evident ,
- \* Surface preparation by grit blasting ,
- \* Erosion rebuilt using Belzona® 1311 ,
- \* Coating with Belzona® 1341 underway ,

Diffuser and bell-mouth from main cooling water lift pump.

Application was carried out in accordance with Belzona Know-How System Leaflets CEP-1, CEP-3 and CEP-5.

Importing of new diffuser and bell-mouth would take six months to deliver at cost of \$100,000. Belzona application cost only \$2,800 and the pump was ready to go back to service in 48 hours.
