BELZONA REPAIR STILL IN PLACE AFTER NINE YEARS & MILLIONS OF PASSOVERS

ID: 429

Customer Location: Missouri Department of Transport - USA
Application Date: August 1994

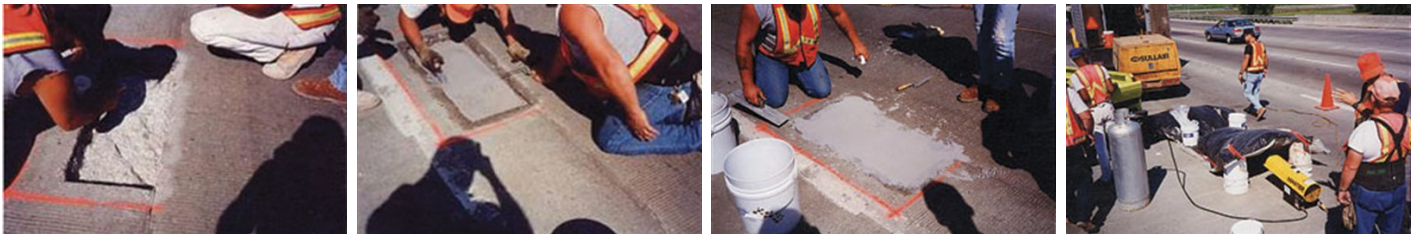
Photograph Descriptions

- * Final stages of surface preparation ,
- * Belzona® 4131 down; ready for next phase ,
- * Belzona® 4111 applied ,
- * External heat apparatus to speed up the lane opening ,

This nine-year-old application is on the busiest stretch of interstate in the state of Missouri - linking St. Louis with Kansas City. The ragged edges and spalled concrete were cut out. Belzona® 4131 was used to fill in the hole, topped off with 1/4"-inch of Belzona® 4111. The application area was then covered with concrete blankets and heated with a gas-fired portable heater. External heat was applied for 50 minutes at 180°F, allowing the lane to open less than four hours later. It's still there today.
