# BELZONA SAVES AUTO INDUSTRY A CHUNK OF CASH

ID: 432

Customer Location: Auto Manufacturing Plant in Missouri,  
U.S.A.

Application: MPT-Mechanical Power Transmission

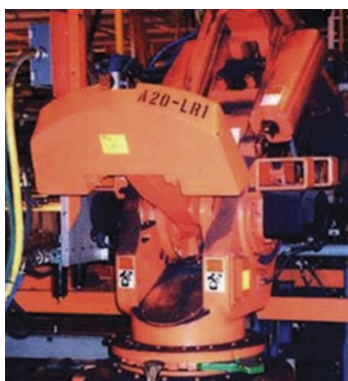
Worn cylinders - welding robot control

- \* Equipment - welding robot ,
- \* Worn cylinder ,
- \* Almost there ,
- \* Completed job ,

Worn shaft

Welding robot control cylinder is simply a spring loaded shaft inside a housing. It controls the movement of the welder to and from the work - (slow going in, very quick return). Once the cylinders became worn, like the one in the photo, the whole assembly was

Application was carried out in accordance with Belzona Know-How System Leaflet MPT-2.

replaced at a cost of \$3,500. The Belzona in-situ repair cost less than 5% of the replacement. There are 400 welders in the production line with two cylinders each.
