BELZONA PROTECTS PASSENGER FERRY JET TUBES

ID: 4343

Customer Location: *Drydock, UK*
Application Date: *November 2012*

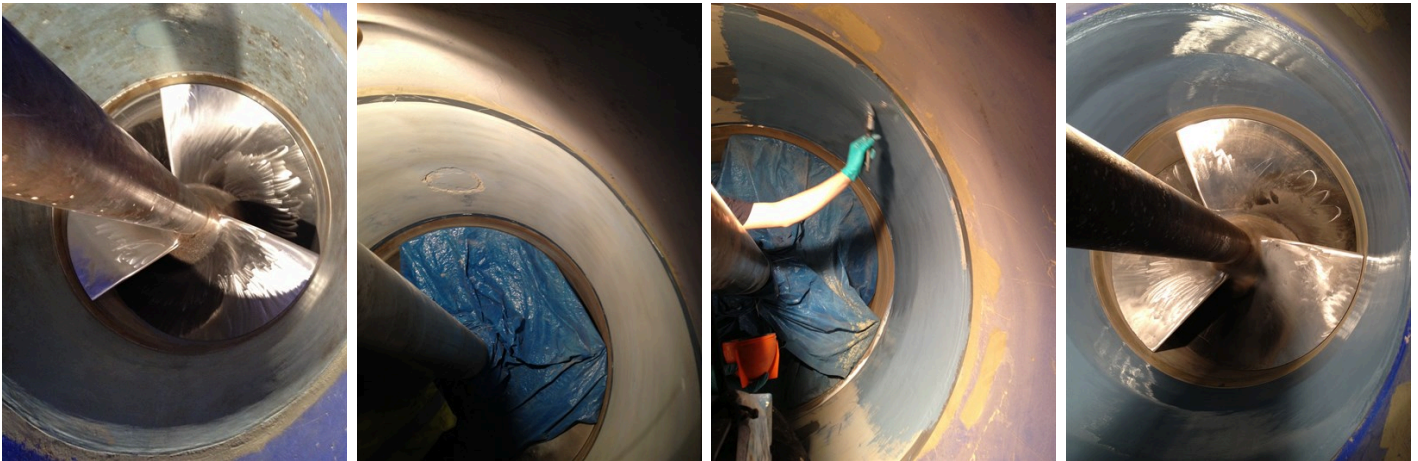
Photograph Descriptions

The jet tubes suffer cavitation due to the high flow rates through them.

* Existing Belzona 1341 still in good condition Flash blast over existing Belzona 1341 Top hat sections rebuilt with Belzona 1111 Belzona 1341 applied to complete the application ,

Application is carried out in accordance with Belzona Know-How System Leaflets SOS-1 & 2. After removing and replacing "top hat" inspection covers, Belzona 1111 applied to fair off before coating entire tube with Belzona 1341.

The application is an annual job that is performed while the ferry is in dry dock. Although most of the Belzona 1341 is intact, by applying an extra coat of Belzona 1341 over the existing Belzona coating the jet tubes are kept in full working service rather than waiting until a major failure.
