BELZONA REBUILDS MARINE DIESEL ENGINE BLOCK

Customer Location: Dockyard, Belfast

Application: ENC-Engines and Casings

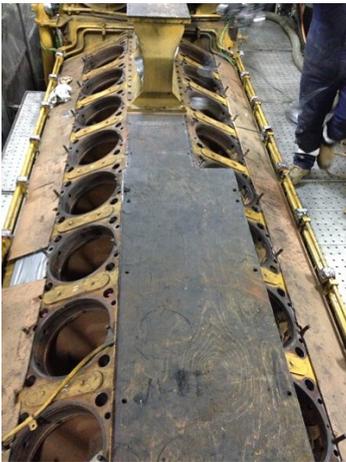
Cylinders from the port outer main engine were suffering from severe cavitation beyond the original Belzona repair. Belzona has been routinely used to repair these areas for over 10 years.

- * 1. General view of the engine Cavitation damage around the existing Belzona® 1311 ,
- * 2. Area ground out to depth of 3mm ,
- * 3. Blasted area in preparation for coating with Belzona® 1391 ,
- * 4. Completed Belzona® 1311 repair ,

Application carried out in accordance with Belzona System Leaflet ENC-6 and engine manufacturers repair procedures. Old repair ground out along with deep pitting. After vacuum blasting area Belzona® 1311 applied to restore profiles. A former was used to create skirt around the cylinder. Area was then flash blasted in preparation for coating with Belzona® 1391.
