BELZONA PROTECTS SLOP OIL TANK

ID: 4354

Customer Location: Offshore Platform, North Sea
 Application Date: 2004

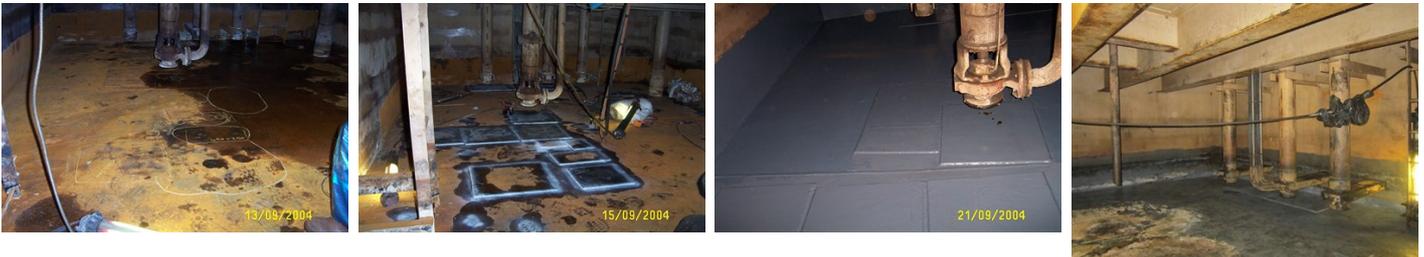
Photograph Descriptions

Severe corrosion of the tank base due to the chemicals, oil and heat involved led to pitting and holing of the tank base resulting in loss of containment.

- * Tank as inspected in 2004 ,
- * Tank base following plate welding ,
- * Initial application completed in 2004 ,
- * Belzona coating as inspected in 2012 ,

Application was carried out in accordance with Belzona System Leaflets TCC-5. Areas of severe corrosion and pitting were identified and repaired using welded plates before the base and 450mm up the vertical walls received a two coat system of Belzona® 1391.

The cocktail of hot aggressive chemicals and oil residue was causing aggressive pitting and corrosion of the existing carbon steel plates. Following inspection in 2012, the lining was found to be in excellent condition requiring only minor remedial repairs. The coating had ensured the tank experienced trouble free service for 8 years.
