BELZONA EXTENDS THE LIFE OF SWIMMING POOL FILTERS

ID: 4356

Customer Location: Swimming pool, Canada
Application Date: July 2004

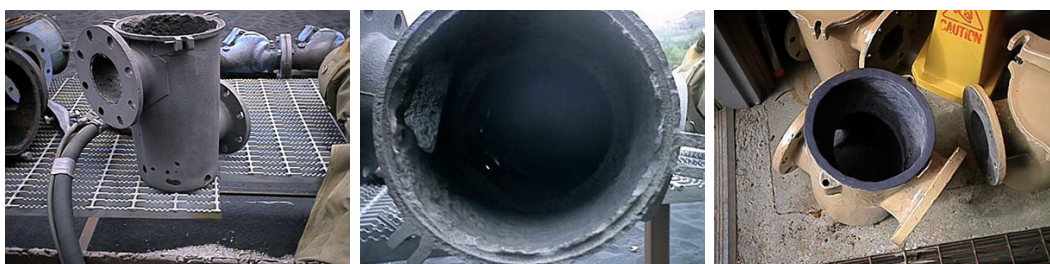
Photograph Descriptions

The filter pots had corroded through in various places. Due to the age of the unit direct replacement not available so replacement of the filter with a new unit would be both expensive and complicated, requiring re-design of pipework.

- * Condition of unit after blasting showing holes in bottom ,
- * Eroded sealing flange ,
- * Rebuilt unit coated with Belzona® 1321 on the inside and Belzona® 5811 on the outside. Note reformed sealing flange face. ,

Application was carried out in accordance with Belzona Know-How Leaflets VPF-1 and VPF-2. Plates were bonded over holes and faired with Belzona 1311 before internal surfaces were protected with Belzona 1321 and externals with Belzona 5811. Sealing faces were also modified to improve seal.
