# NON-SLIP SAFETY SYSTEM IN HOSPITAL DISH WASHING ROOM

ID: 436

Customer Location: Regional Hospital - British Columbia,  
Canada

Application: FPA-Floor Problem Areas

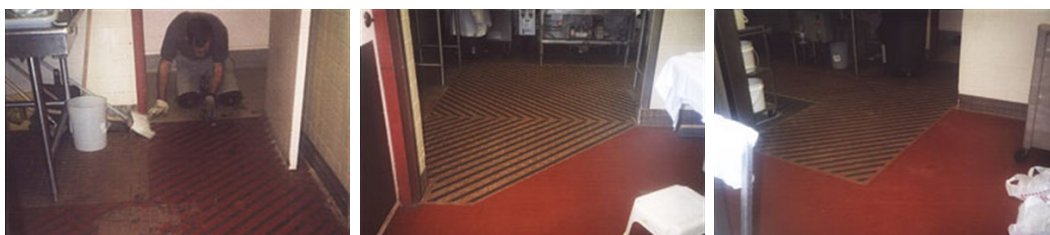
Inferior non-slip safety system

- \* Previous failed system being stripped from the floor ,
- \* View of application ,
- \* View of another section of the application ,

Customer had contracted with another vendor to apply a non-slip safety system to the dish wash room floor. However, soon after completion of the application, it was found that the surface was extremely slippery. Belzona was approached to apply our standard system over this coating. Within a few months the inferior coating started to delaminate. We were contracted to remove all the red coating and apply a Belzona safety grip system directly to the original floor tiles. Photograph shows removal in progress.

Application was carried out in accordance with Belzona Know-How System Leaflet FPA-8.
