BELZONA PROTECTS DAMAGED BOOSTER FAN

ID: 4363

Industry: Power
Application: FBC-Fans, Blowers and Compressors

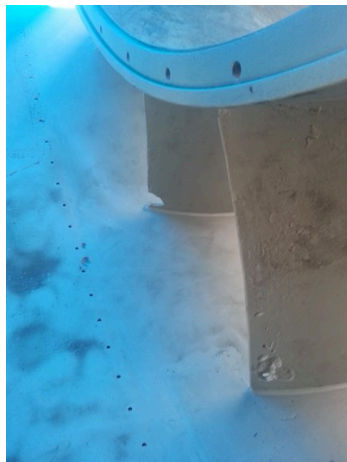
- * 1. Damaged booster fan. ,
- * 2. Pitting damage and blasted substrate. ,
- * 3. Application of Belzona 1391T. ,
- * 4. Finished application. ,

The booster fan from an electric powerplant had damage on the case around the diffuser and the fan housings. Damage caused by high temperatures and corrosion. Previous BIRR coating failed.
