BELZONA PROTECTS DAMAGED BOOSTER FAN

ID: 4363

Industry: *Power*
Application: *FBC-Fans, Blowers and Compressors*

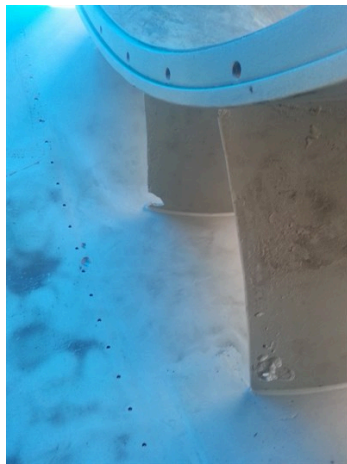
- * 1. Damaged booster fan. ,
- * 2. Pitting damage and blasted substrate. ,
- * 3. Application of Belzona 1391T. ,
- * 4. Finished application. ,

The booster fan from an electric powerplant had damage on the case around the diffuser and the fan housings. Damage caused by high temperatures and corrosion. Previous BIRR coating failed.

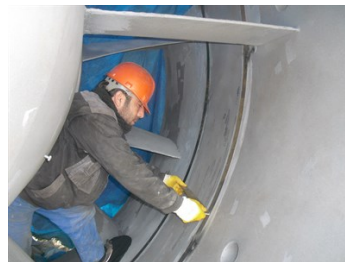
General and pitting corrosion occurring across the fan housing and diffuser. Pitting was filled and then whole area was coated with Belzona high temperature coatings.

Pitting was filled using Belzona 1111. While in the overcoating window, 2 coats of Belzona 1391T were applied.
