# LARGE NON-SLIP SAFETY SYSTEM APPLICATION

ID: 437

**Customer Location:** Regional Hospital - British Columbia, Canada.

**Application:** FPA-Floor Problem Areas

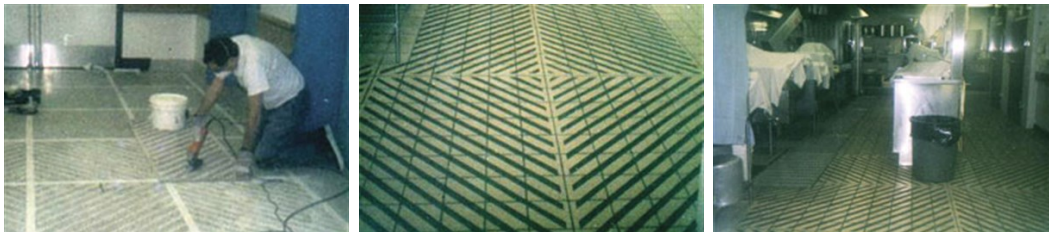
- \* Preparation underway using a special silicon carbide grinding tool and template ,
- \* Hospital opted for various different 'chevron' style patterns to help break up the areas ,
- \* Another view of application with a different pattern ,

Hospital kitchen and dish washing areas were a constant safety problem because of wet floors. It was determined that the prevention of a single compensation claim would be more than sufficient to justify the cost of the complete application.

Safety system required in hospital kitchen, dishwashing room, and hallway. Total area completed approximately 1,400 square feet.

Application was carried out in accordance with Belzona Know-How System Leaflet FPA-8.
