# BELZONA® 1521 PROTECTS OIL/GAS/WATER SEPARATOR

ID: 442

Customer Location: North Sea Oil & Gas Producer

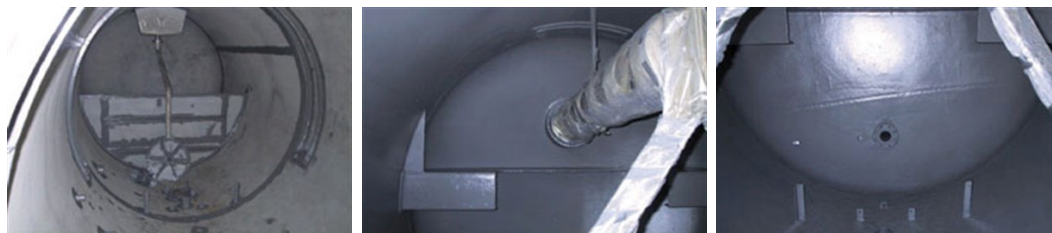
## Photograph Descriptions

*Corrosion of the equipment caused by failure of the existing lining system required complete removal of the coating.*

- \* Stripe coating of welds, nozzles and brackets ,
- \* Completed upper half of vessel ,
- \* Completed weir area and brackets ,

Following grit blasting, stripe coating was completed using Belzona® 1391 for all nozzles, welds and brackets. Following reblasting Belzona® 1521 was applied using heated airless spray.
