# BELZONA COLD BONDING STOPS PIPE VIBRATIONS

ID: 4486

Customer Location: Petrochemical Plant, Bohai Bay, China  
Application Date: 2010

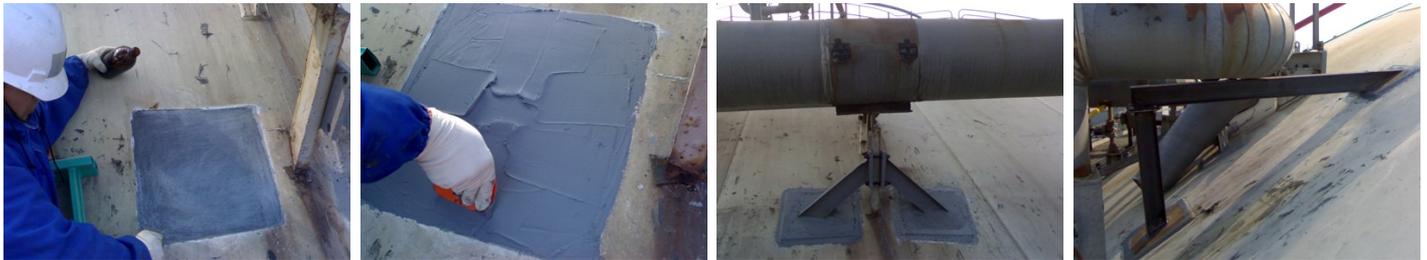
## Photograph Descriptions

- \* Surface preparation ,
- \* Application of Belzona® 1111 ,
- \* Application completed ,
- \* Overview of the tank top pipework ,

During loading and unloading, the pipework suffered from vibration. Increased frequency of loading and discharge was exacerbating the problem and structural damage was a concern. Additional supports were designed to solve problem but due to safety restrictions, no hot work was allowed. Cold bonding of additional supports using Belzona was therefore specified.

Belzona provided the client with the solution to eliminate vibrations by installing additional supports on the tank roof. The cold bonding avoided hot work. The modification was achieved in just 4 hours.
