# BELZONA EMERGENCY LEAK SEALING: THREE HOURS LATER - IT'S READY

ID: 450

**Customer Location:** Fertilizer producer in Egypt  
**Application Date:** October 2003

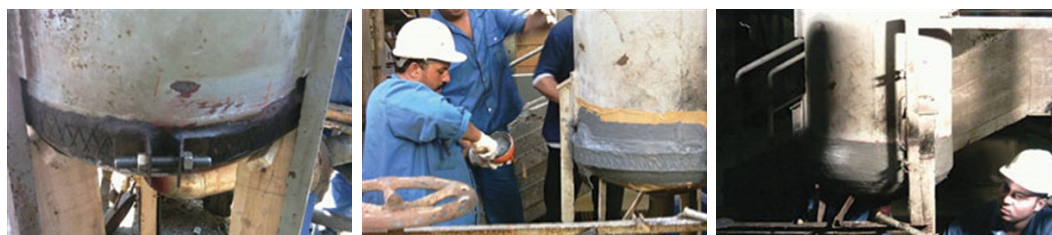
Corrosion of vessel had caused leak.

- \* Belzona® 1291 used in conjunction with metal clamp to initially stem the leak ,
- \* Belzona® 1111 plus Belzona® 9341 (Reinforcement Tape) applied to strengthen the repair ,
- \* Repair completed in 3 hours ,

Belzona® 1291 was initially used in conjunction with a metal clamp to stem the leak before applying Belzona® 1111 with Belzona® 9341 (Reinforcement Tape) to complete the application. Repair completed quickly and safely without heat so preventing the need for a major plant shut-down.
